Tree Condition Report

Durham Road Play Area,
Wiltshire

8th May 2017

Job Ref: 0872

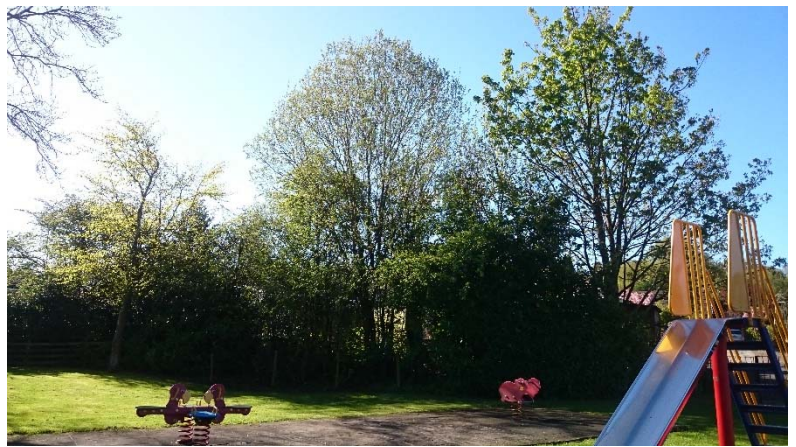
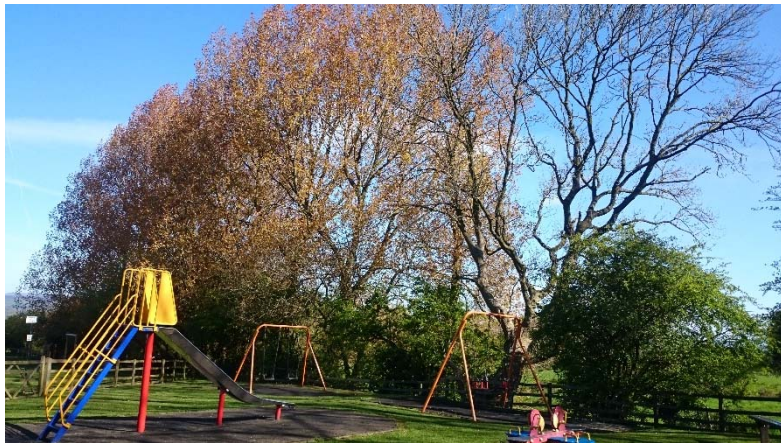
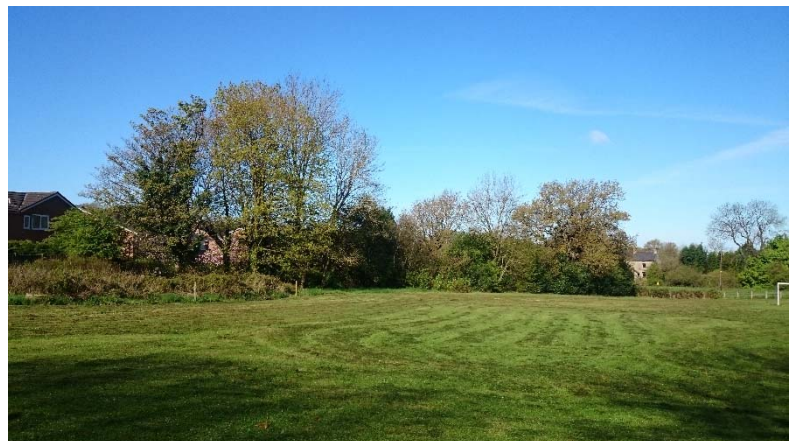
19. Photos

As a whole the trees are in good condition and none are in need of removal. Remedial pruning works are recommended, this primarily to remove any deadwood and to raise the height of the canopy branches to prevent encroachment and give clearance to head height and ride on grass cutting machines.
