Tree Condition Report

Durham Road,
Wilpshire
Play Area

Wilpshire Parish Council

Job Ref: 1637

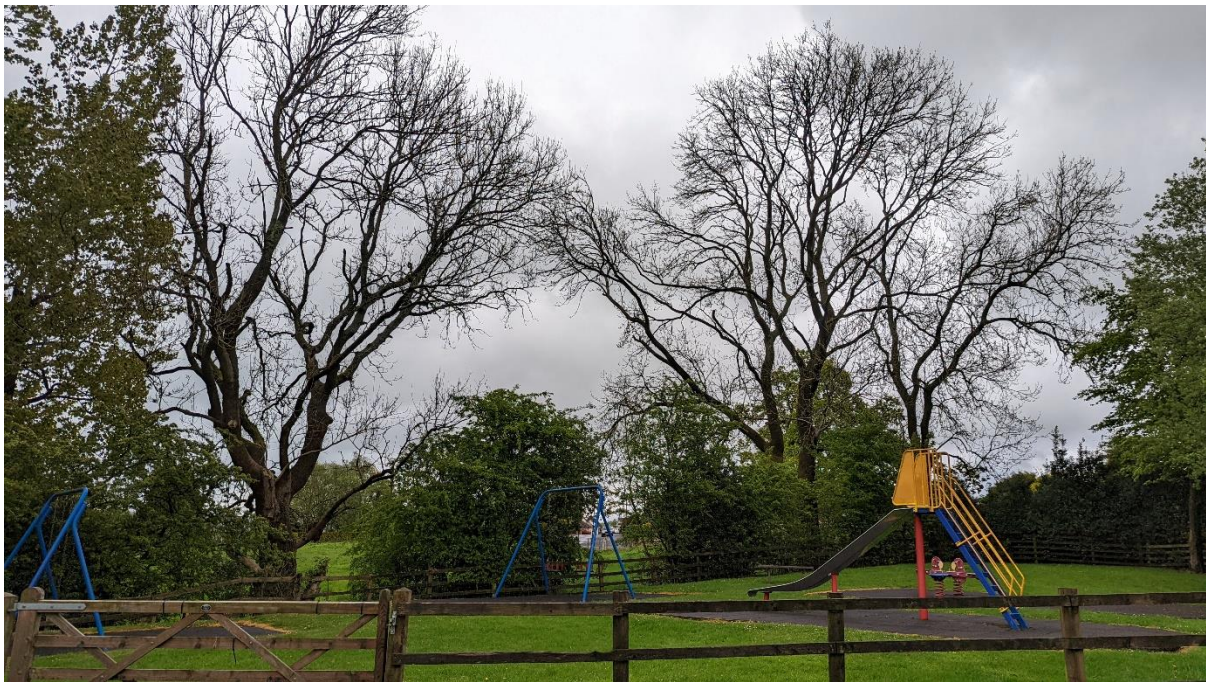
T4, T5 and T6 Ash - not in full leaf

T	5	Ash	1	800	18	14	Mature	Fair	Fair	10+	C1	_ No significant visual root defects	_ No significant visual stem defects	_ No significant visual branch defects	_ Moderate deadwood 25-100mm dia	_ Tree not in leaf potential for Ash dieback to have affected tree	No fungi visible at time of inspection	_ Garden+_ Open Space+_ Play Area	No	Notify land owner for them to carry out a more formal assessment - potential for tree to be removed	3mths	12mths
T	6	Ash	1	1000	18	14	Mature	Fair	Fair	10+	C1	_ No significant visual root defects	_ No significant visual stem defects	_ No significant visual branch defects+_ Heavy branch loading	_ Moderate deadwood 25-100mm dia	_ Tree not in leaf potential for Ash dieback to have affected tree	No fungi visible at time of inspection	_ Open Space+_ Play Area	No	Notify land owner for them to carry out a more formal assessment - potential for tree to be removed	3mths	12mths

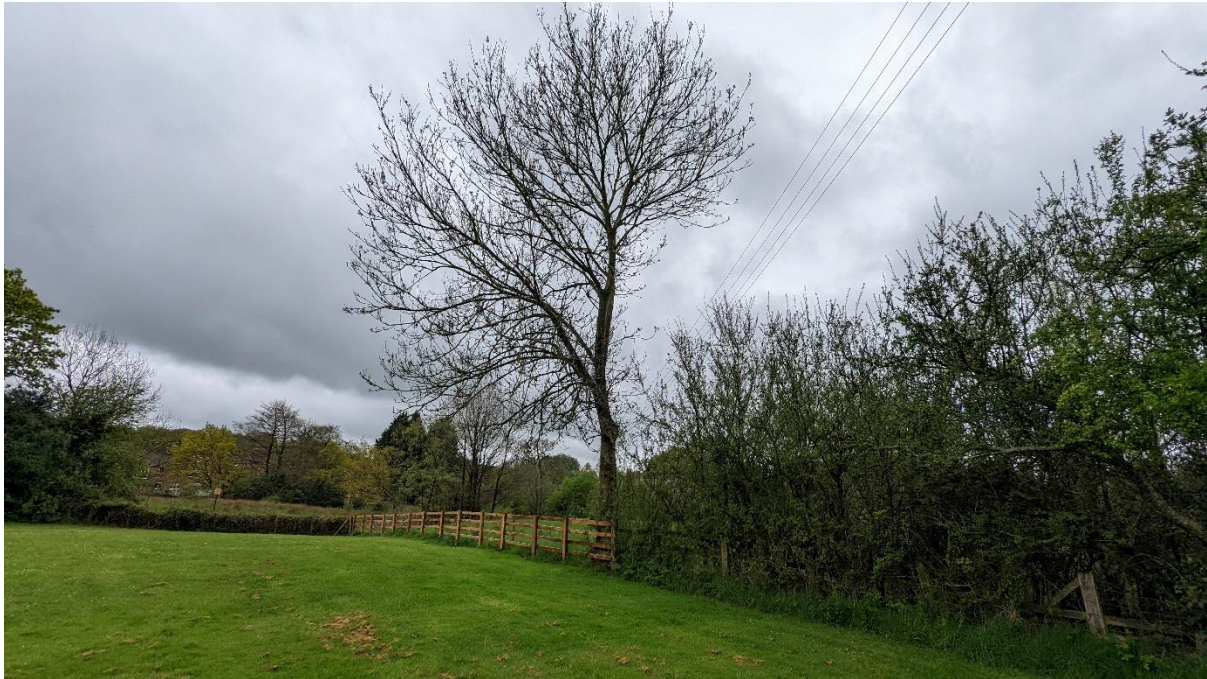
T19 Ash not in full leaf

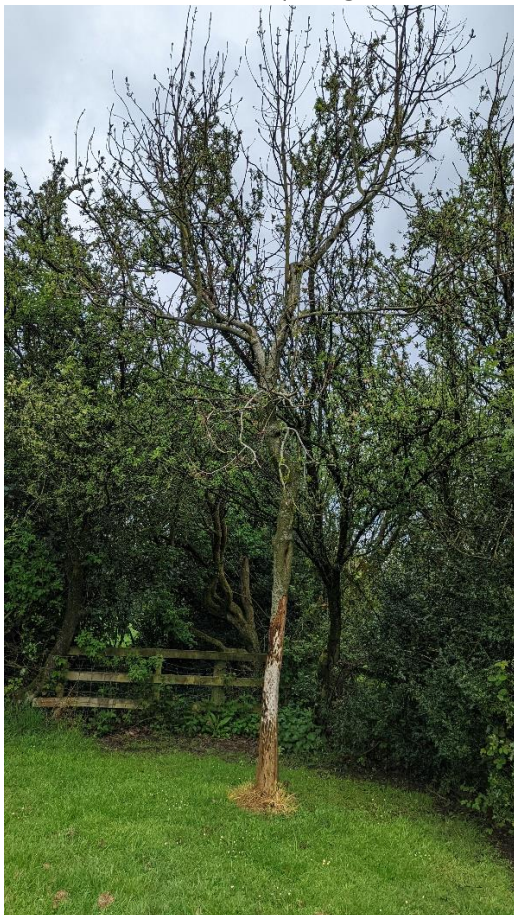
T18 Ash – in decline requiring removal

T	18	Ash	1	200	8	6	Young	Poor	Poor	<10	U	_ No significant visual root defects	_ bark damage and decay	_ Deadwood present	_ Tree not in leaf potential for Ash dieback to have affected tree	Potential for Ash dieback to have affected tree	Ash Dieback Present	_ Open Space+ Play Area	No	_ Remove tree to ground level	6mths	Not Applicable
T	19	Ash	1	250	10	8	Semi Mature	Good	Good	40+	B1	_ No significant visual root defects	_ No significant visual stem defects	_ No significant visual branch defects	_ Moderate deadwood 25-100mm dia	_ Tree not in leaf potential for Ash dieback to have affected tree	Potential for Ash dieback to have affected tree	_ Open Space+ Play Area	No	Notify land owner for them to carry out a more formal assessment - potential for tree to be removed	3mths	12mths
T	20	Oak	1	800	16	16+	Mature	Good	Good	20+	A1	_ No significant visual root defects	_ No significant visual stem defects	_ No significant visual branch defects	_ Moderate deadwood 25-100mm dia	_ No significant visual foliage issues	No fungi visible at time of inspection	_ Open Space+ Play Area	Yes	_ No work required at time of survey	Not applicable	3yrs
